**RE: QUARTERLY PROGRESS REPORT FOR THE AVTEX FIBERS SUPERFUND SITE FOR THE
PERIOD OCTOBER 1 THROUGH DECEMBER 31, 2020 (FOURTH QUARTER)**

SITEWIDE QUARTERLY INSPECTION REPORTS

Quarterly Inspection Report

Quarterly Inspection Report Photographic Log
Avtex Superfund Site
Front Royal, Virginia

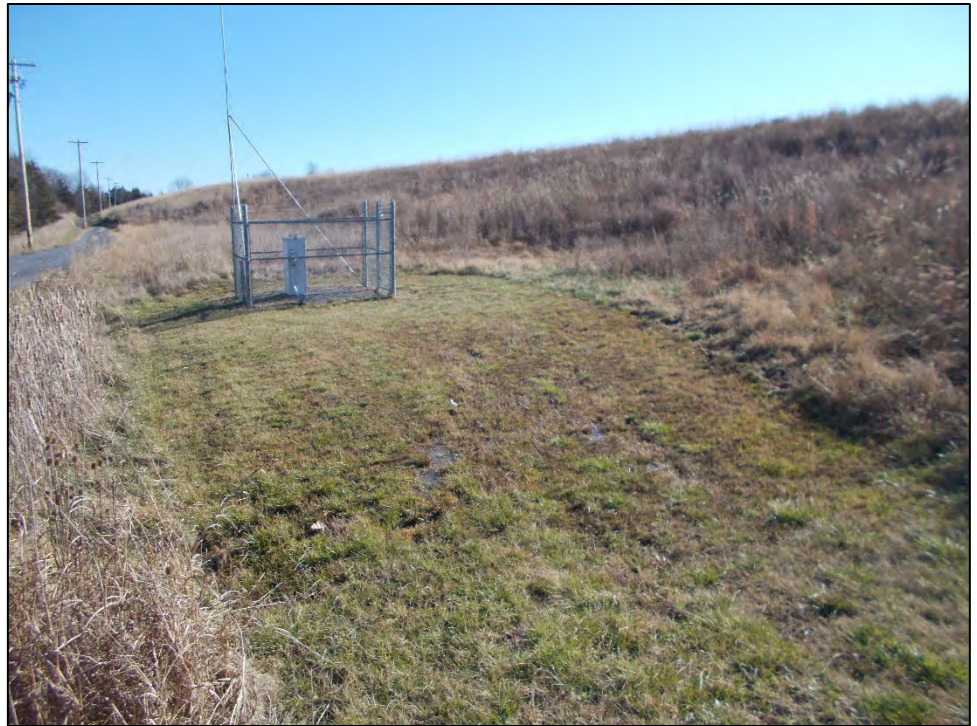
Photo Number: 1

Photo Description: Two areas of former standing water adjacent to LS-2. Wet due to recent rainfall

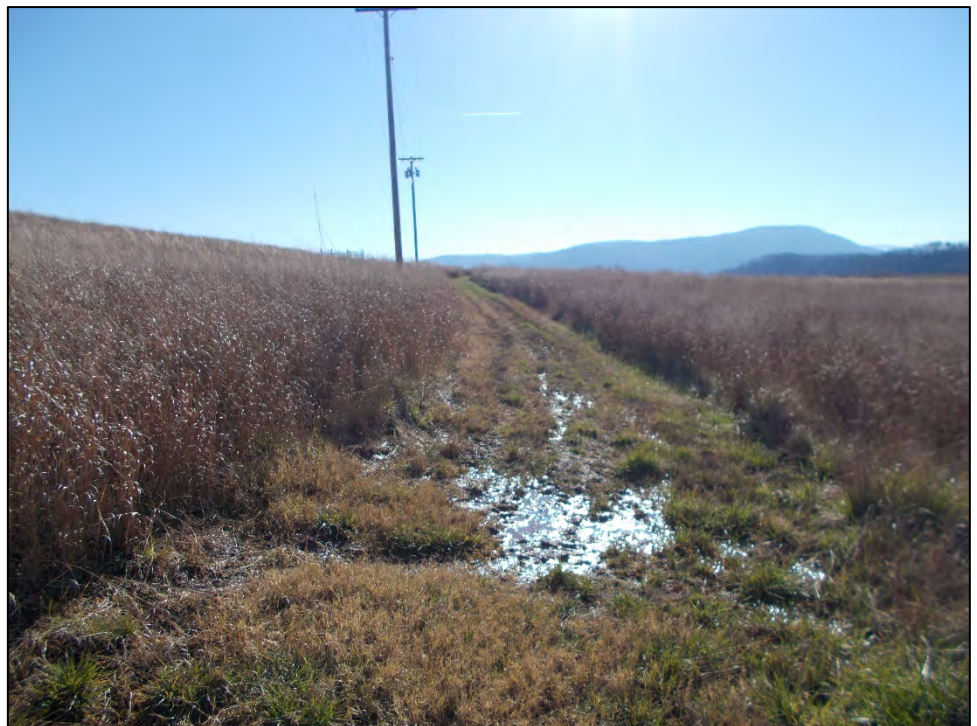
Photo Number: 2

Photo Description: Standing water on access path west of VB-4,5, & 6 (path to LS-1)

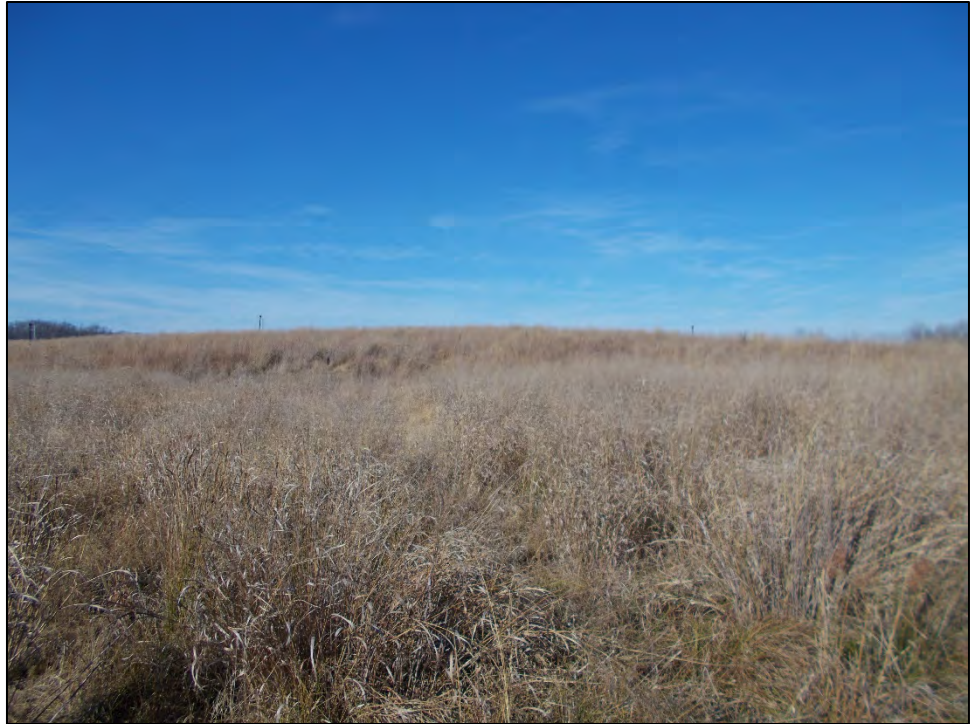
Photo Number: 3

Photo Description: Area of Former Standing Water (grass growing).

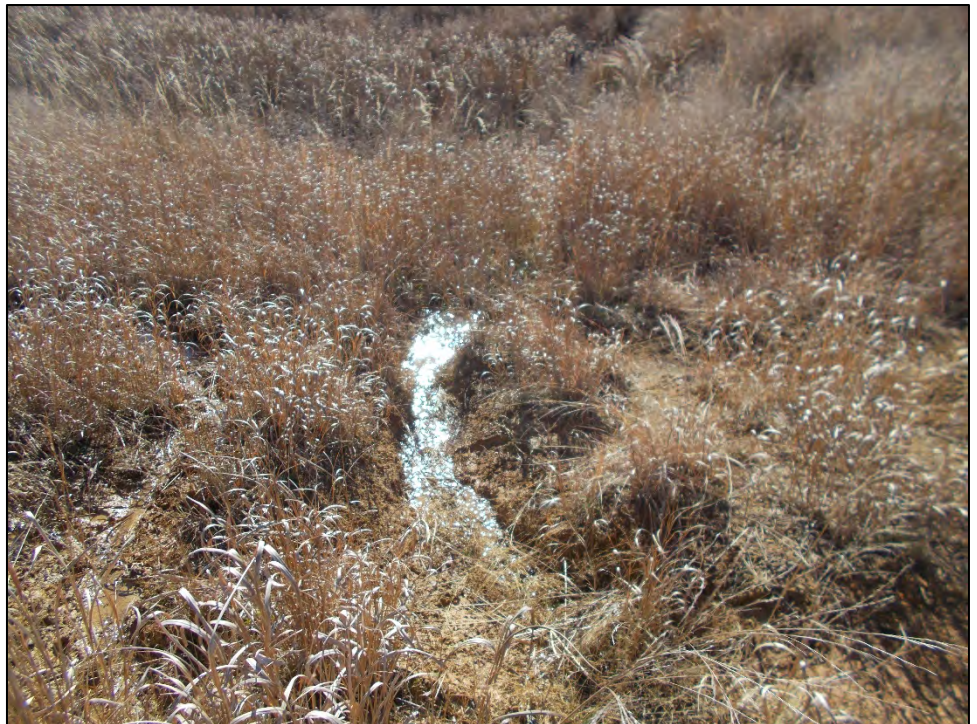
Photo Number: 4

Photo Description: : Bare soil (~10' x30') with rills southeast of VB-2&3 (Sediment basin between NLF and VB-2&3). Stable and dry, grass returning. Water flowing due to recent rain.

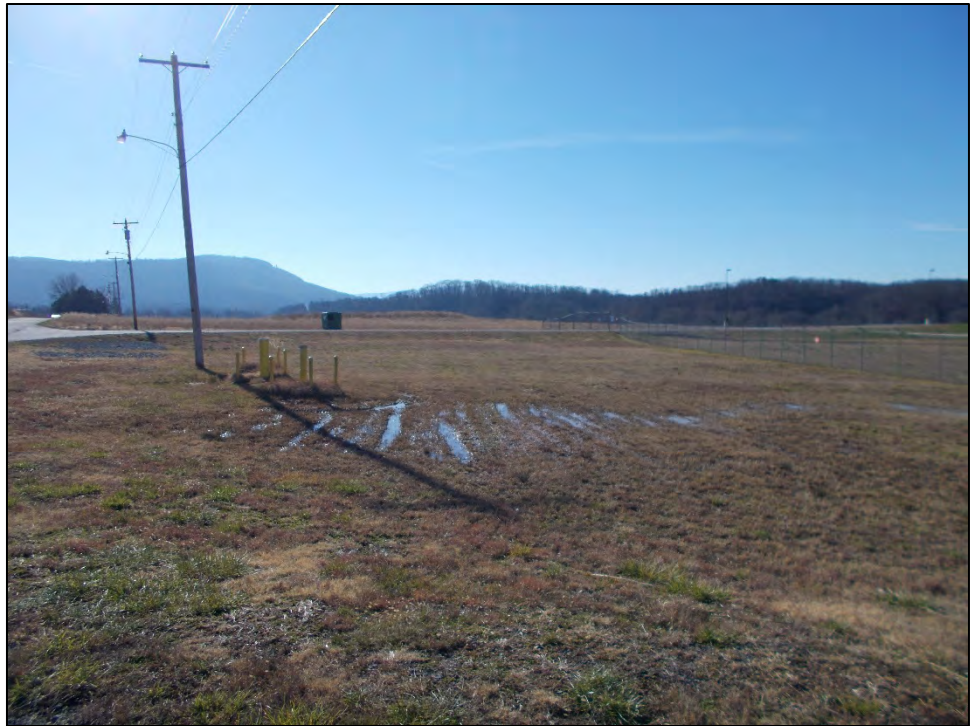
Photo Number: 5

Photo Description: Area around wells 103/203/303 – wet due to recent rainfall.

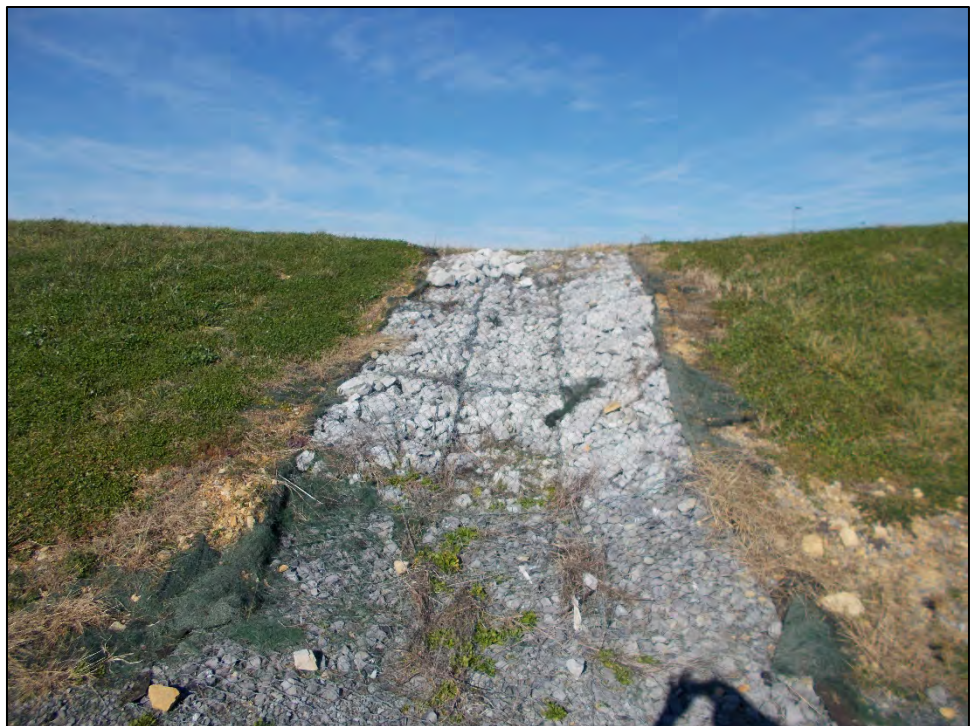
Photo Number: 6

Photo Description: Bare patches and exposed matting at down chute in south side of VB-10.

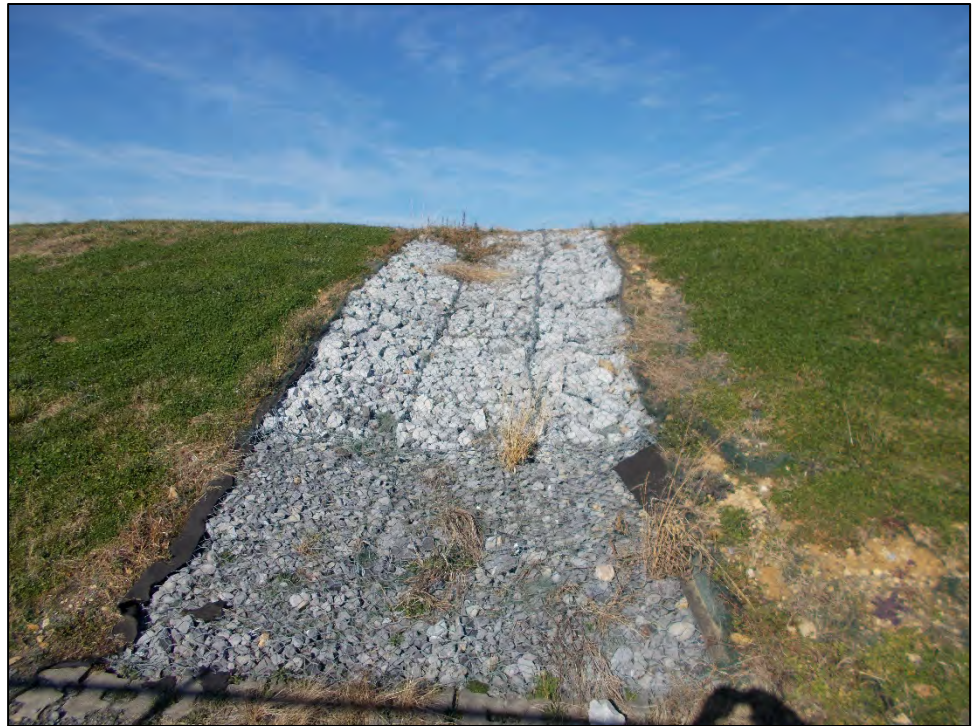
Photo Number: 7

Photo Description: Bare patches and exposed matting at down chute on south side of VB-10.

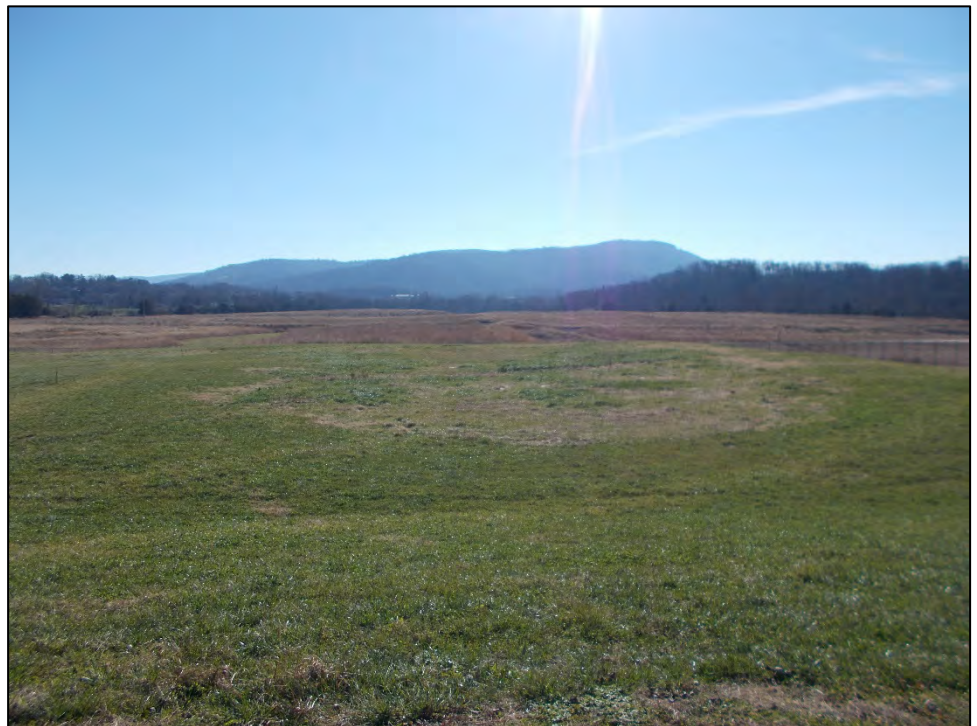
Photo Number: 8

Photo Description: Settlement in southern section of VB-10 – repairs complete.

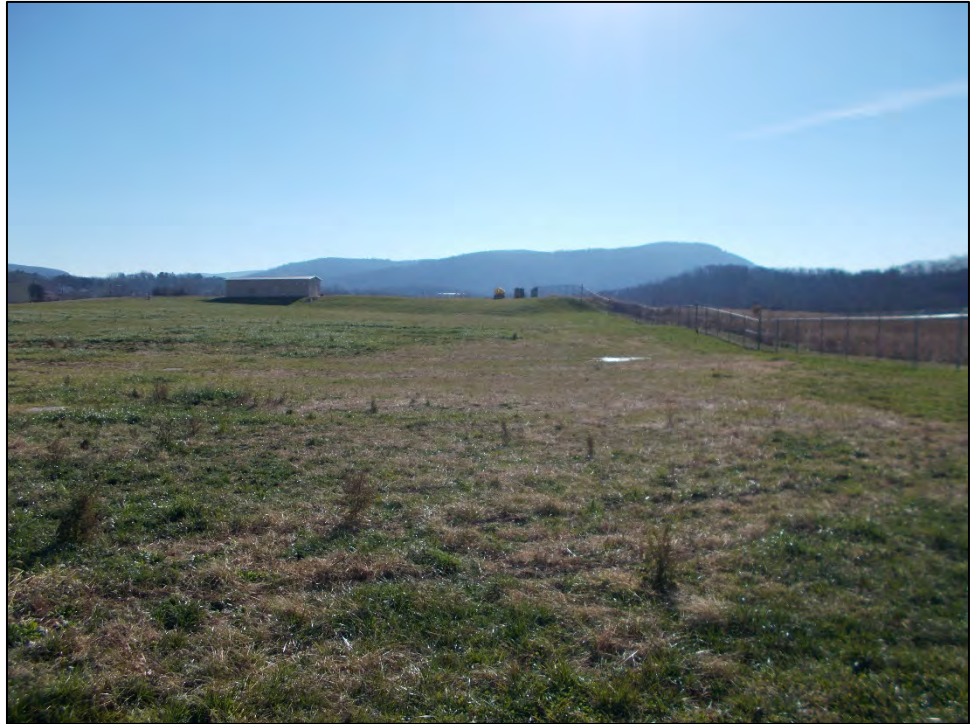
Photo Number: 9

Photo Description: Former settlement on previously repaired area on VB-9 (30' x 40)- repairs complete and grass growing. Small area of standing water due to recent rainfall.

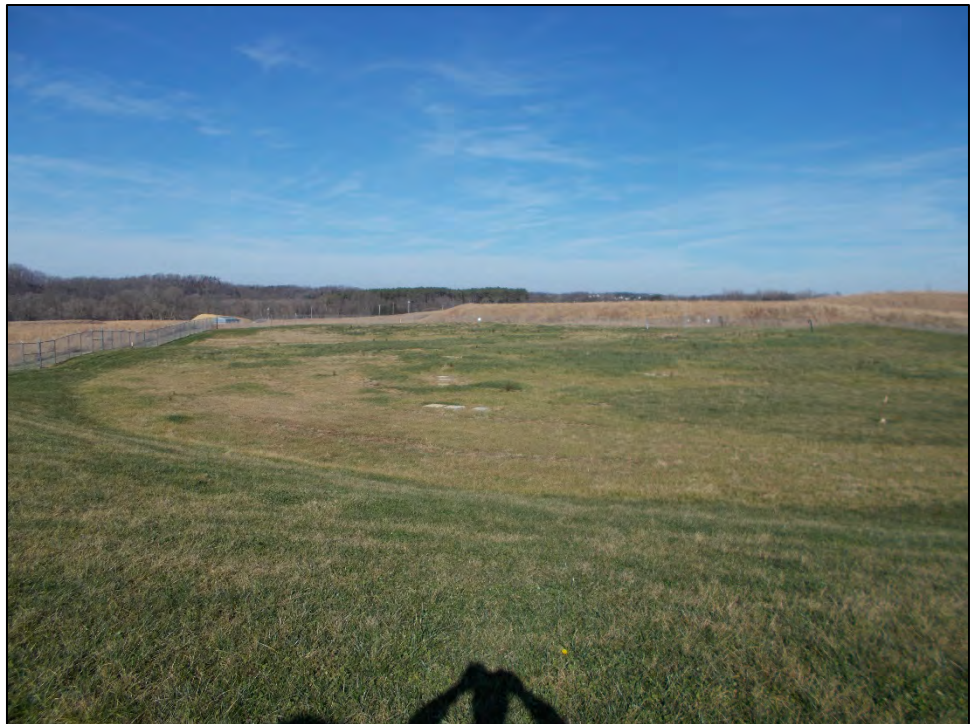
Photo Number: 10

Photo Description: Former settlement on previously repaired area on VB-9 (30' x 40)- repairs complete and grass growing.

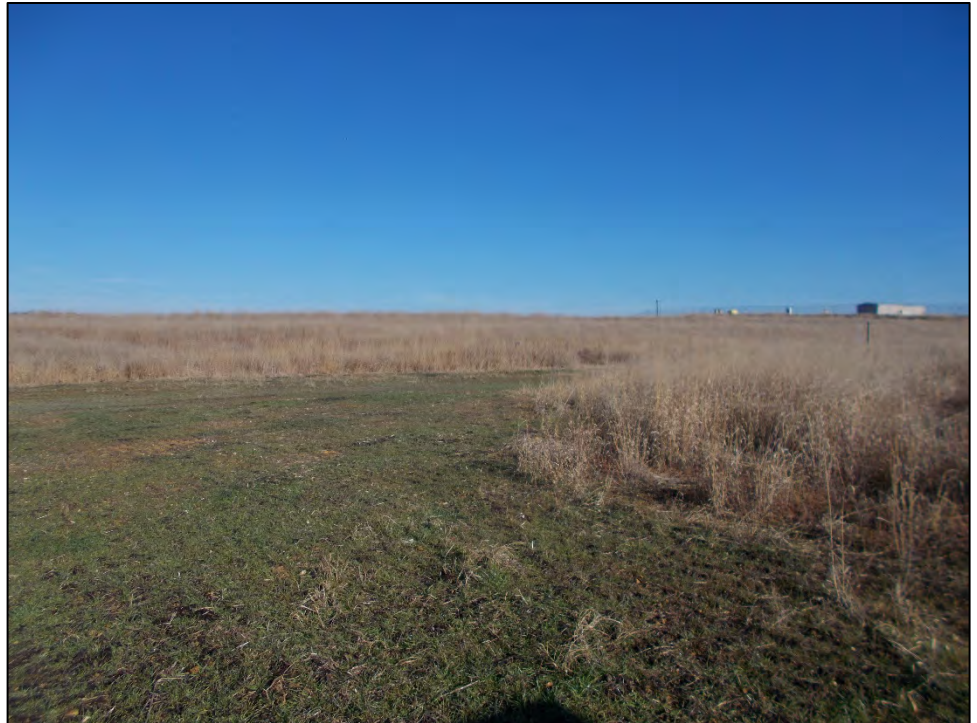
Photo Number: 11

Photo Description: Former areas of settlement in front of inlets between SB-3 and SB-2 – repairs complete and grass growing.

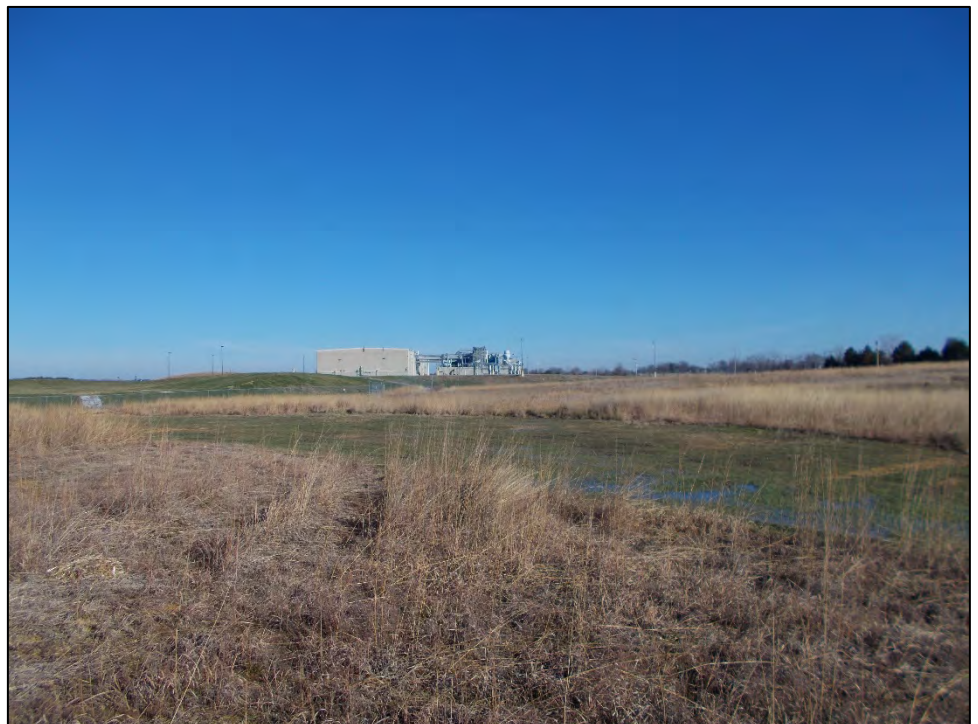
Photo Number: 12

Photo Description: Former area of settlement on FAB-3 – repairs complete and grass growing.
